Report of Geologic Reconnaissance

**Danube Storage Facility
12410 Lakeside Avenue
Lakeside, CA 92040
MUP 08-002, ER 08-14-001**

February 4, 2009

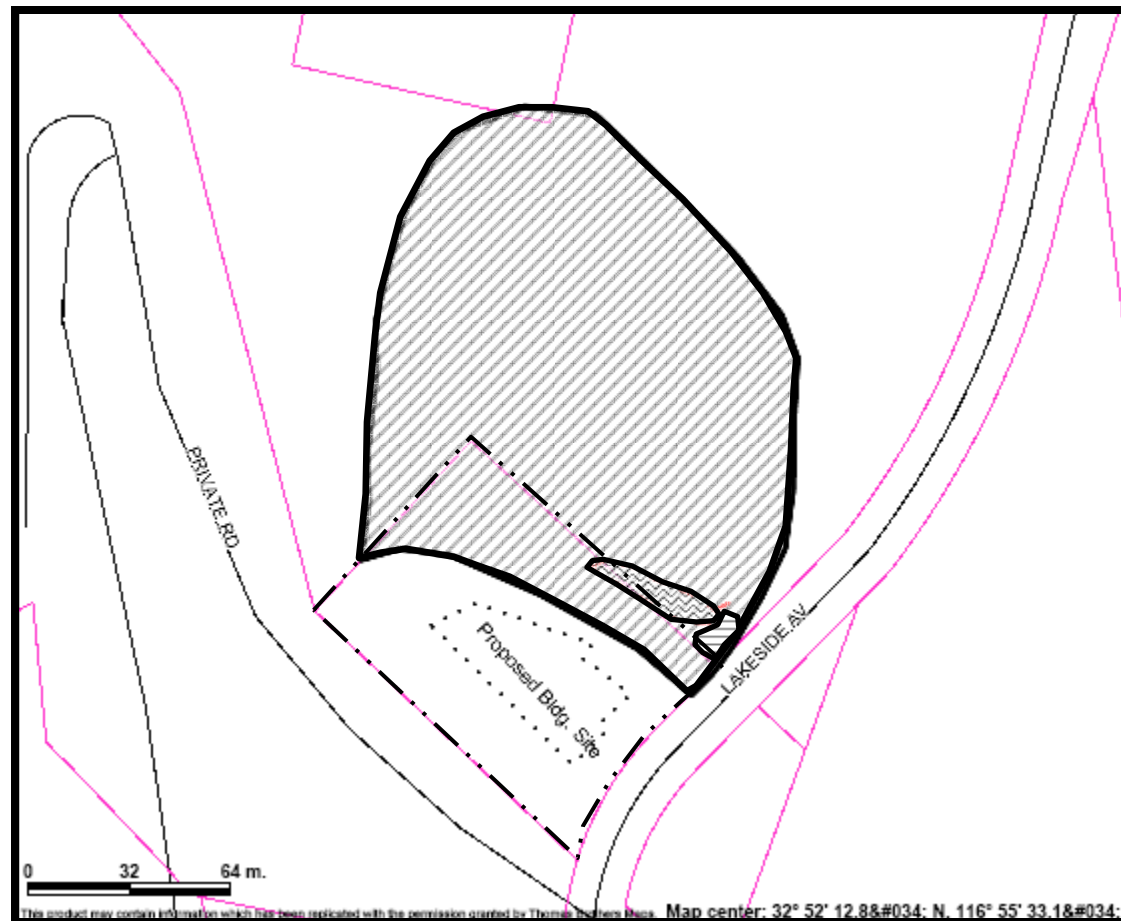
Figure 4

Area A: Evidence of a few loose rocks/boulders susceptible to falling/rolling downslope were observed during this site reconnaissance directly upslope or near the planned building pad area (Figure 3 and 4, Photograph 2). These boulders are located less than 100 feet above the planned building pad and appear to be remnant boulders from former grading activities at the site. Some of these boulders may require removal or stabilization which could be accomplished during grading of the site for development. Mitigation could be achieved by using standard grading equipment, and is feasible due to relatively easy access to susceptible boulders above the project pad area. Some of these boulders appear to be offsite on the parcel directly north of the site and may require permission from the neighboring property owner prior to removal/stabilization.

Area B: Other boulders/outcrops observed during our field visit (Figure 4) that could potentially affect the planned building pads appeared to be buried to a significant degree and not sitting directly on the ground surface, and/or irregularly shaped with their long axis perpendicular to the slope face. Based on the observed character of the granitic boulders and outcrops, the potential for rockfall to adversely affect the proposed building in these areas is less than significant.

Area C: Thicker deposits of colluvium were observed near the base of the slope in the northeast portion of the project site (Figure 4). Based on this observation, it is likely that

future gravitational downslope creep and/or sheet wash on the slope above the site will cause additional accumulations of colluvium at the base of the slope over time. Unless the slopes were to become completely denuded in the event of a fire or grading, debris flow from the slopes would not present a substantial risk to the planned building pad area at the site. In addition, based on review of aerial photographs and observations during the reconnaissance of the site, there is no evidence of substantial landslides that have occurred on the slopes above the proposed project.

Intent: In order to avoid rockfall hazards that threaten the proposed building site, the boulders located in a hazardous position shall be removed.

Description of requirement: The boulders identified in “Area A” in the February 4, 2009 Report of Geologic Reconnaissance prepared by the Department of Planning and Use (DPLU) shall be removed/relocated as part of the grading of the site.

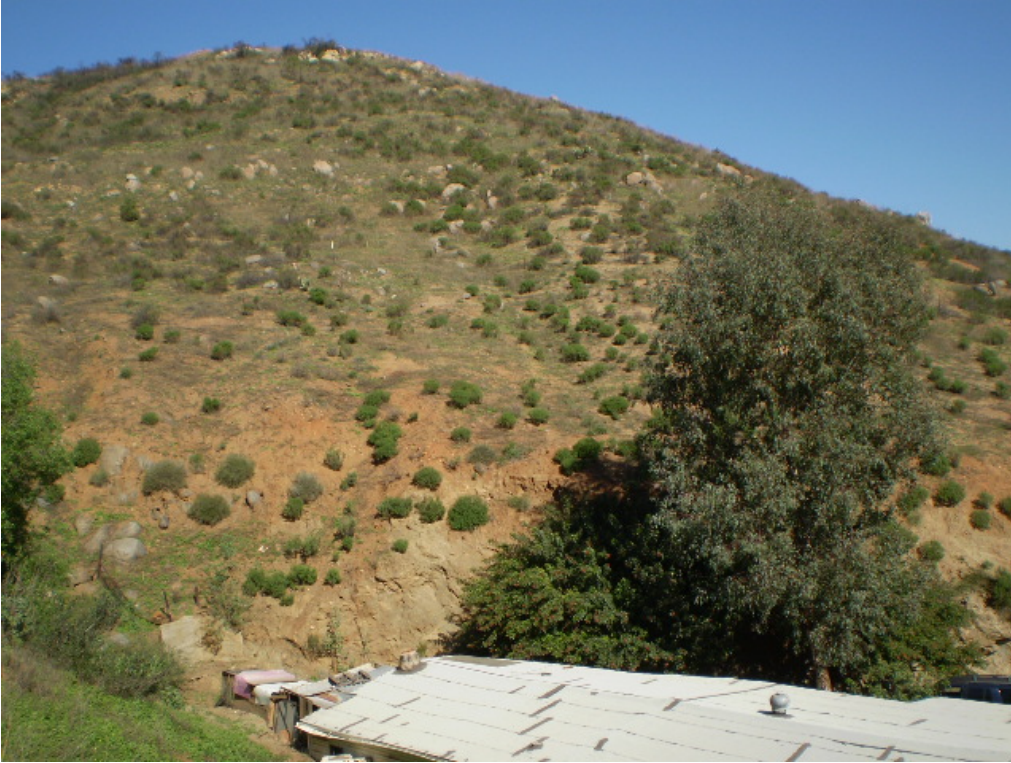
Photograph 1: View to the north of slope above site with existing site structure in the foreground.

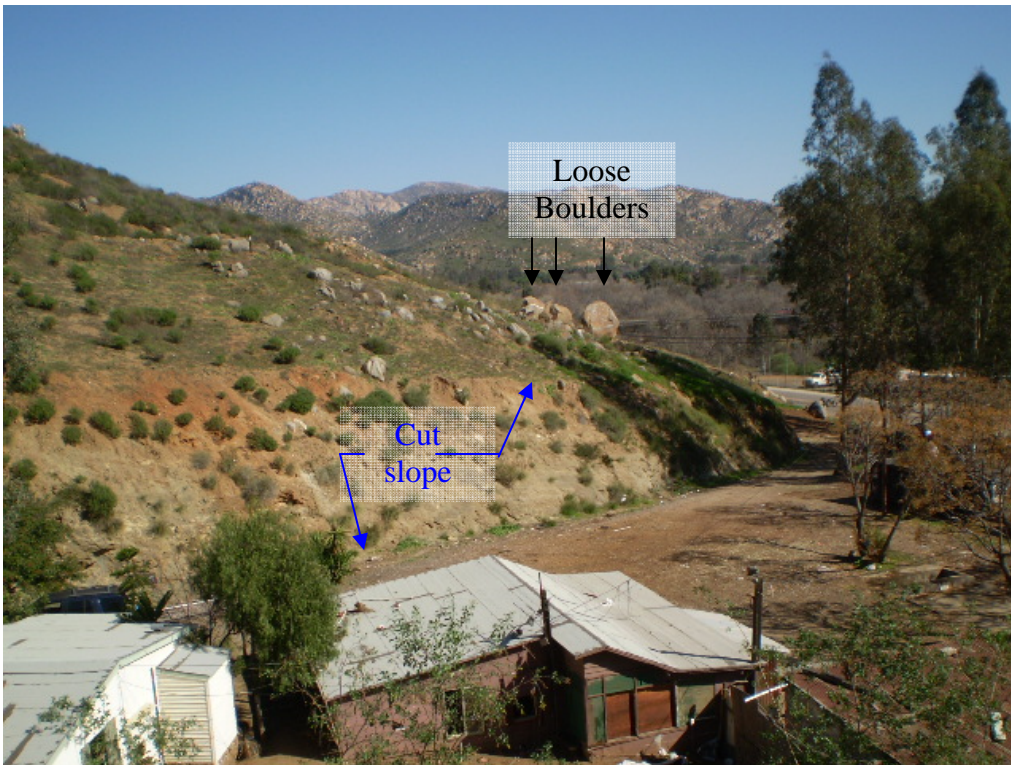
Undifferentiated Granitic Rocks: Crystalline granitic rock of intermediate composition was observed as outcrops in sporadic locations on the slopes on and to the north of the site. Partially buried boulders mostly less than 5 to 6 feet in diameter were observed in sporadic locations on the slope north of the site (Photograph 1). Much of the slope appeared disturbed and showed evidence of former grading activities. The bottom of the slope has an artificial cut face in which residual soil and partially intact bedrock was observed (Photograph 2).

Photograph 2: View to the northeast with the site and its existing structures in the foreground. Note cut slope and loose boulders.
